Model: PC8000 Serial #: N/A	Jul. 29, 2020
Product Bulletin # PC-049 v 1.0

PC8000 Ramp Channel Repair Work

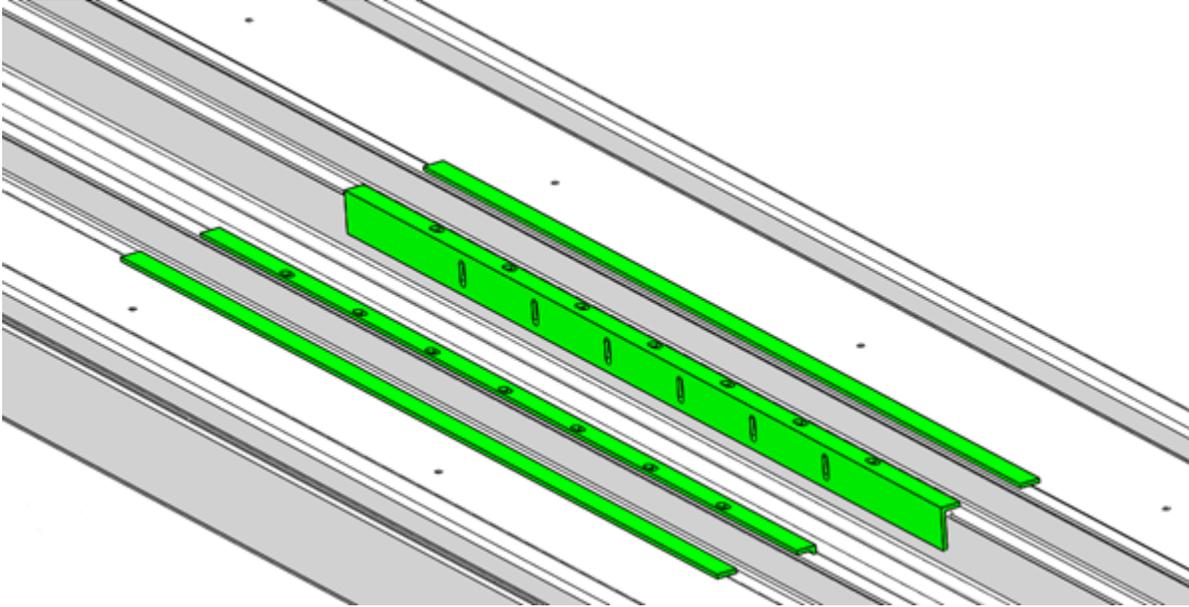
Figure 1: Rework Side Support Detail View

As shown in Figure 1 and Figure 2 on page 2, the L-angle and flat bar reinforce the area where the carrier rollers may cause damage to the ramp C-channels.

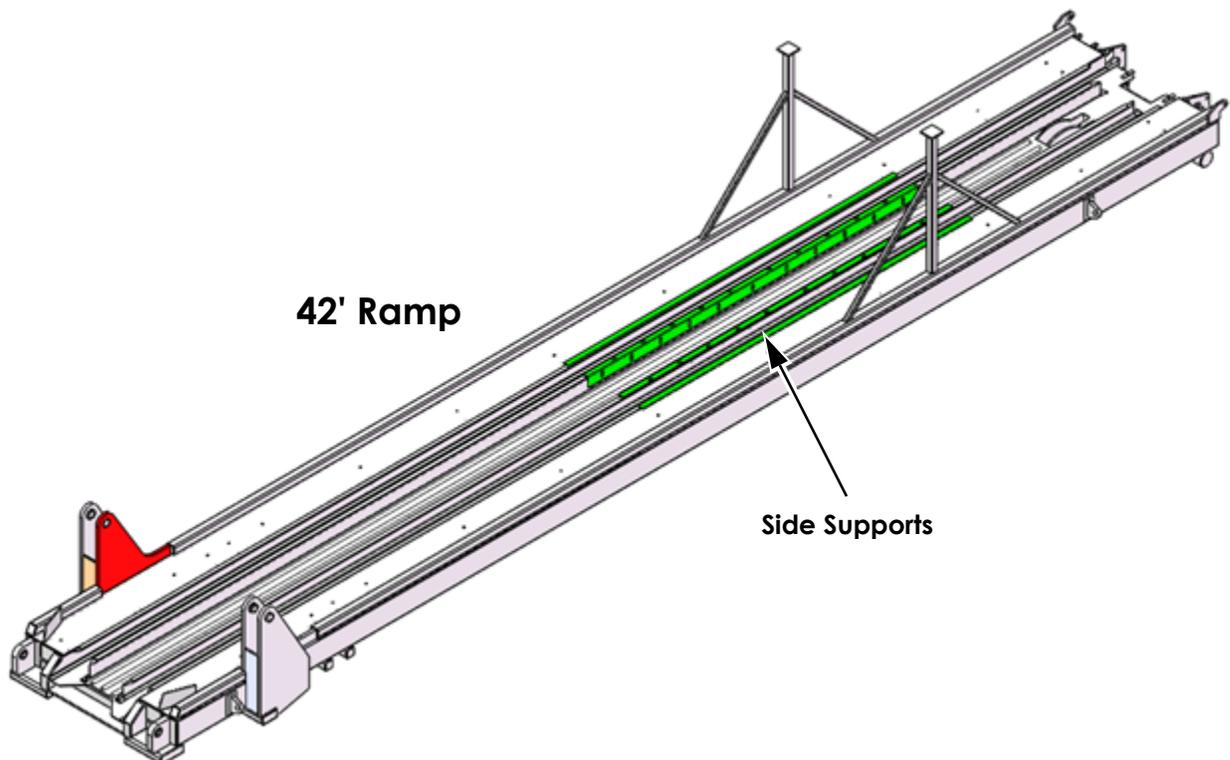
Figure 3: 42' Ramp supports location

42' Ramp

Support bars 170" long, located towards top of ramp.

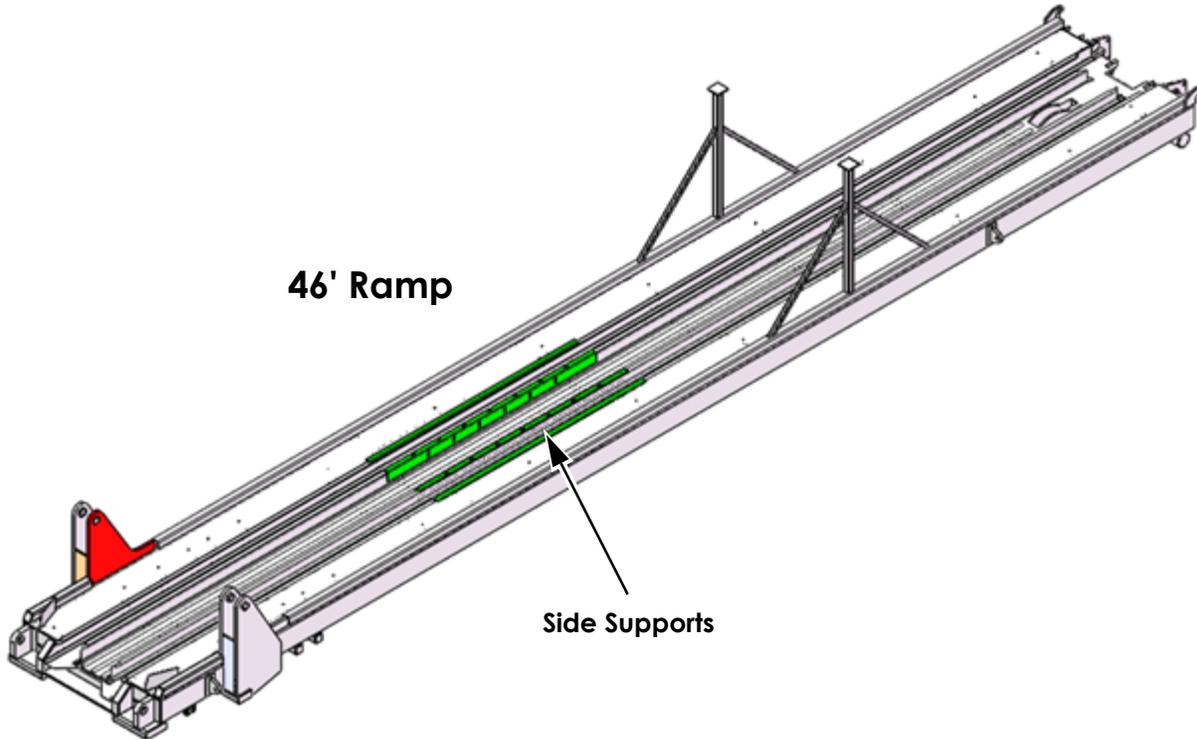
Figure 4: 46' Ramp supports location

46' Ramp

Support bars 118" long, located towards bottom of ramp.

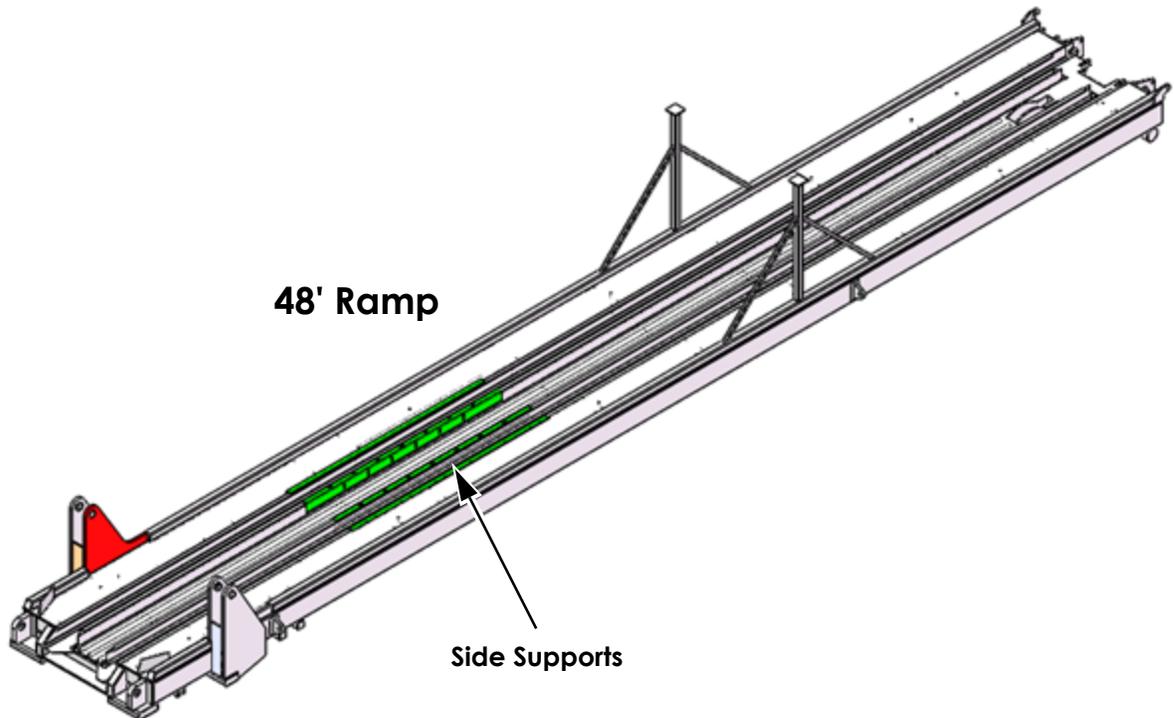
Figure 5: 48' Ramp supports location

48' Ramp

Support Bars 118" long, located towards bottom of ramp.
