Model: All Canrig Top Drives

Product Bulletin # TDS-239 Rev 5

Alert

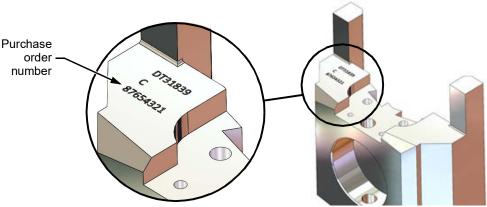
Figure 1: Location of purchase order number

See Figure 1 for location of stamped purchase order number on the part.
