SAFETY ALERT

DATE: October 14, 2002

- SUBJECT:** Mounting plate – Handler Rotate Lock
- SERIAL NUMBERS:** 25-27, 34-35, 39, 42, 48,50,55-56, 66, 83, 106, 121, 126-127, 130-131, 133, 135-137, 141, 147

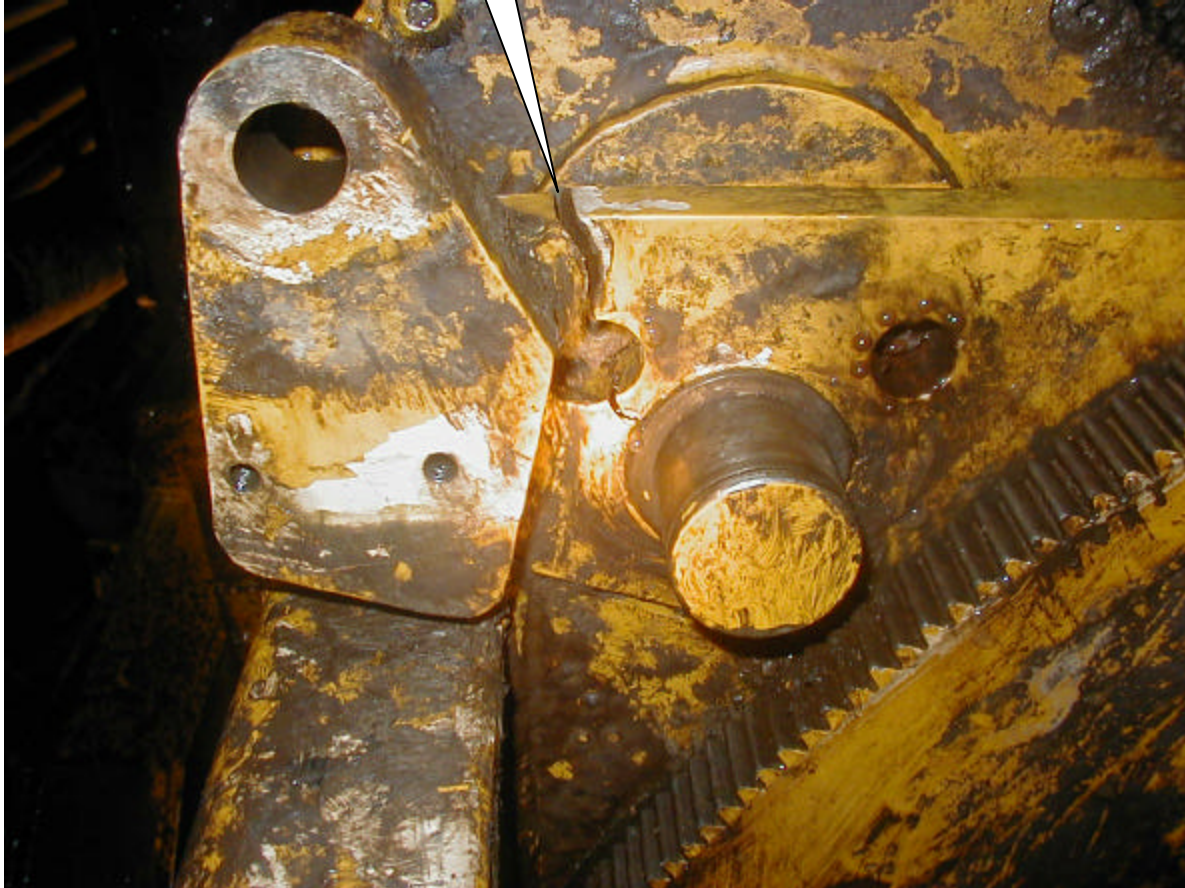
- DISCUSSION:** A Top Drive recently developed a significant crack on the mounting plate, where the handler lock dog is attached. This crack could result in the malfunction of the handler lock and is considered a critical situation, if left unattended.

Picture of cracked mounting plate

Crack
developed
here

- RECOMMENDATION:** *Inspect mounting plate for cracks at the lock dog hinge pin, using MPI (see attached drawing for detailed location and previously issued product bulletin 36 for additional information).* If any cracks are detected, the **integrity of the handler lock mechanism is compromised** and the mounting plate must be repaired or replaced as soon as possible. Contact CANRIG for repair procedures. Further, CANRIG has improved replacement plates available upon request.

- If the plate shows no signs of cracks, repeat this inspection periodically (at least every 12 month), to ensure reliable operation of the handler lock.

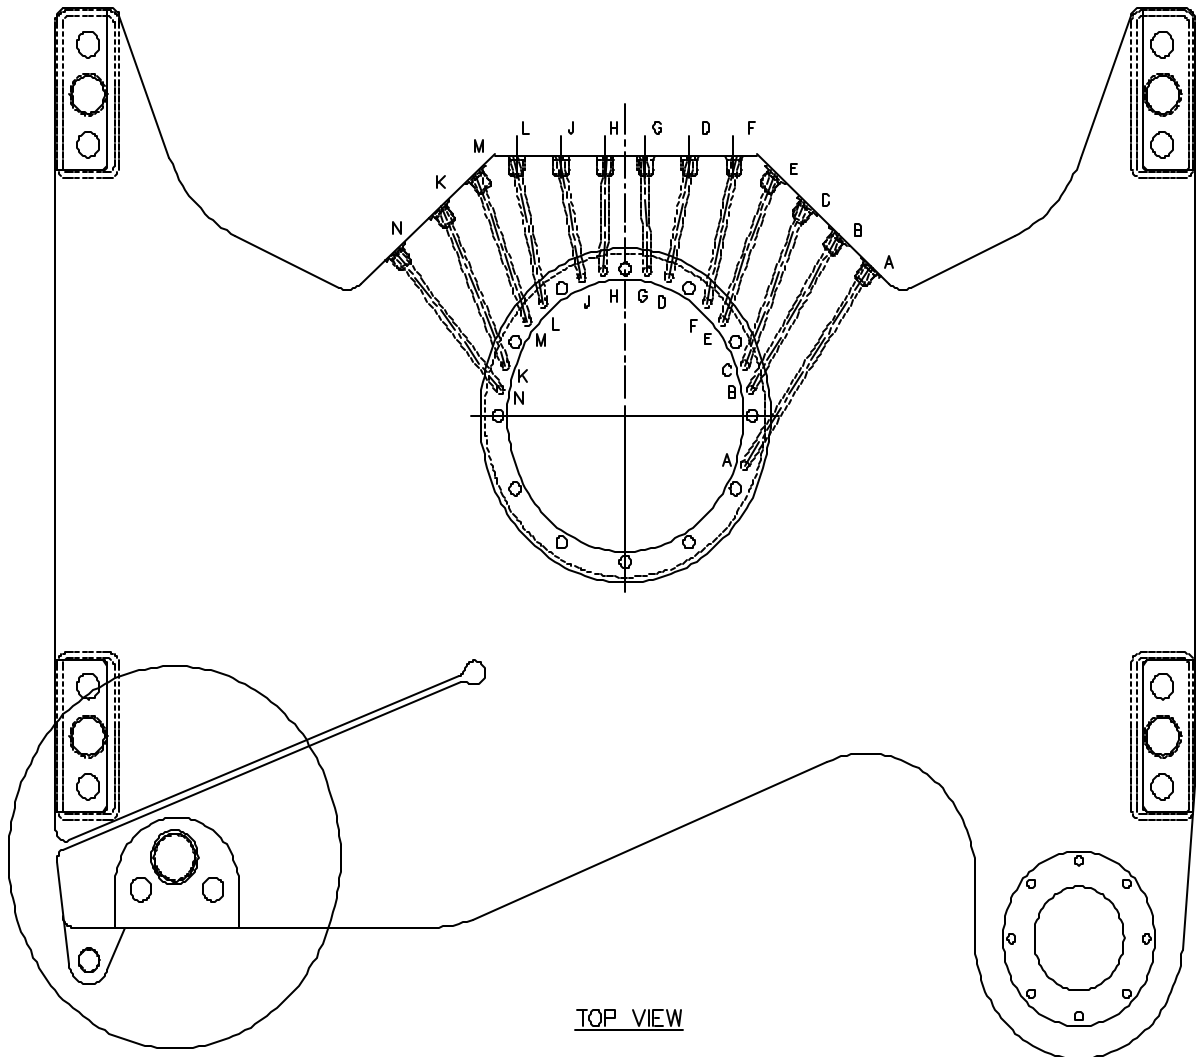
Mounting Plate drawing that shows where crack has been found

Area where cracks may develop
