PRODUCT BULLETIN CATWALK NUMBER: 011

PRODUCT: AUTOMATED CATWALKS April 30, 2009 DATE:

SUBJECT: Cracks in Carrier Sides (reference bulletin # CATWALK 10)

SERIAL NUMBERS: PM3000-1001 to PM3000-1160 / 300158 to 300177

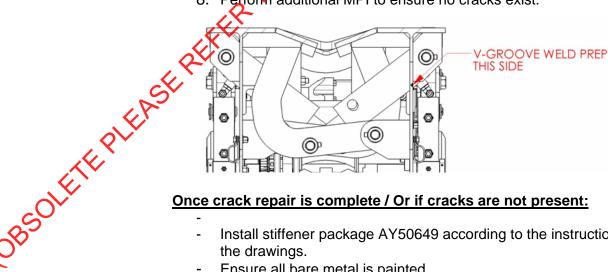
DISCUSSION: There has been incidents of cracking in the Carrier W-Beam web which

> has been occurring at the kicker cylinder mount locations rearest to the lightening holes. This seems to be happening mostly when handling

tubulars in excess of 6000 lbs.

RECOMMENDATION: If cracks are present:

1. Remove paint a minimum of 1" in all directions around the crack on both sides of the Carrier beam web.

- 2. Perform a 1/4" V-prep along the crack on the outside of the Carrier beam web. Ensure the weld prep extends 1/4" beyond the end of the crack.
- 3. Perform MPI to ensure extent of V-prep is beyond crack.
- 4. Cautiously apply preheat until average temperature reaches 200 degrees F - do not heat until red.
- 5. Using an E70/18 Yow Hydrogen rod, perform a 1/4" backing weld on the side opposite the V-prep.
- 6. Using an \$\overline{7}\dot{018} Low Hydrogen rod, weld the V-groove fully.
- 7. Allow to air cool; do not quench.
- 8. Perform additional MPI to ensure no cracks exist.
