Technical Bulletin

No: TB060

Date: September 12, 2008

Description: Installation and Maintenance of CDS™ Link Tilt Cylinders

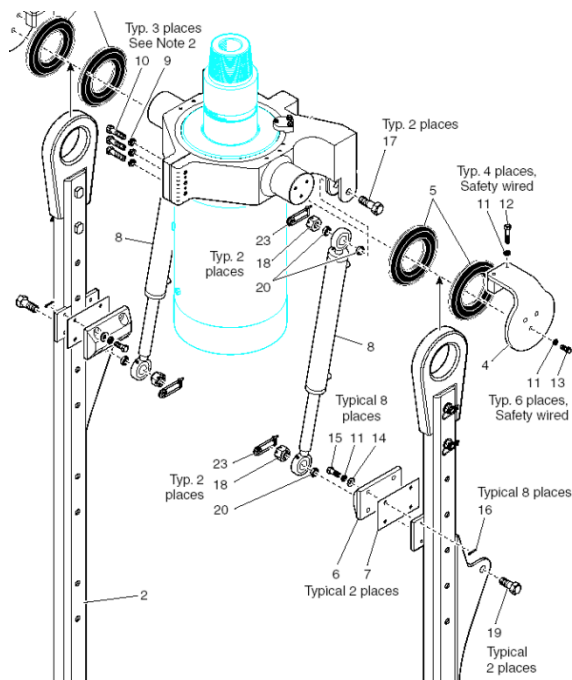
Figure 1 – (a) CORRECT installation, (b) INCORRECT installation – spacer is missing

2. Complete an inspection of the link tilt system. Ensure that rod end spacers are installed at each of the cylinder rod ends as described above and as shown in Figure 1a. Visually inspect equipment for signs of impact damage, and check for excessive play in rod ends. Rod ends with more than 1/32" of free play in any direction are considered worn beyond service limits and should be replaced.

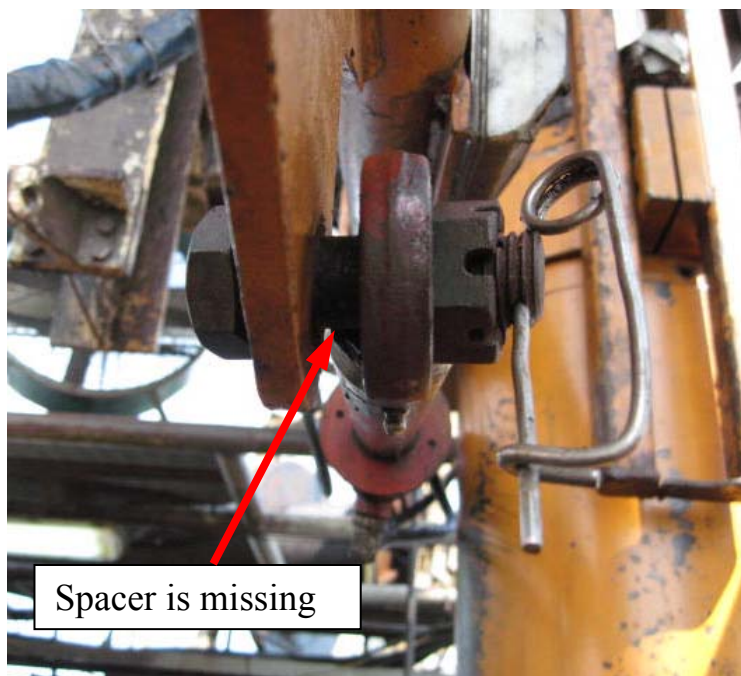
(b)

A dropped object incident occurred where a piece of the rod end bearing on a TESCO Casing Drive System™ (CDS™) link tilt fell to the rig floor. The subsequent incident investigation identified improper installation and maintenance to be significant contributors to the incident. Specifically, the rod end spacers (items 20 in Figure 1a) that are required between the cylinder rod eyes and the link tilt side plates were not installed, and adequate application of grease to the rod ends was not being performed. It was found that the maintenance manual for the CDS™ system does not specifically call out periodic greasing and inspection of the link tilt cylinder rod end bearing. Figure 1a shows the CORRECT installation with rod end spacers (items 20); Figure 1b shows the INCORRECT installation without spacers.
