Do Not Weld on ICDS and CCDS Mandrels

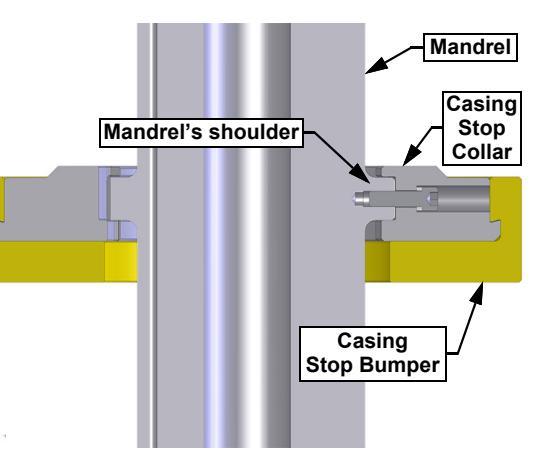
One of the features of the Internal Casing Drive Systems (Internal CDS and Internal Compact CDS) is a Casing Stop Collar that prevents the ICDS/CCDS tool from being stabbed too deep into the casing and damaging either the ICDS/CCDS tool or the casing. The Casing Stop Collar sits against the Mandrel's shoulder that stops it from moving vertically up when it unintentionally hits the casing. Several bolts hold the Casing Stop Collar in place.

It came to Canrig's attention that some customers have welded the Casing Stop Collar to the Mandrel on some of their CDS tools.

Welding on the load path components including ICDS & CCDS mandrels is not permitted. The unauthorized welding may affect material properties and cause defects or cracks which may cause component catastrophic failure.

Remove from service, scrap and replace any ICDS & CCDS Mandrels found to have been welded.
