Model: ILLUMIC™

Product Bulletin # CLS-001 Rev 1

ILLUMIC™ Crown Lighting System Issues

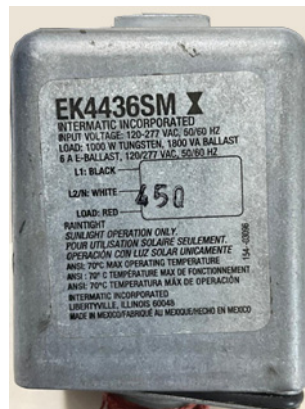
Figure 1: Incorrect photocell

- 30 Amp circuit breakers for the lighting circuits are being used in some locations instead of the 20 Amp circuit breakers called out in the Engineering BOM and drawings.
- Some of the plugs are not fastened tightly per the plug manufacturer's specifications.
- The photocell (E19578) supplied is the incorrect part number. Manufacturer's part number EK4436SM is the wrong part. Canrig's part specification requires Intermatic K4136M or equivalent.

The incorrect photocell will overheat damaging the device.

2. Tightly fasten plugs per the manufacturer's specifications. Refer to manufacturer's instructions.
3. Remove incorrect photocell (see Figure 1 on page 1) from the circuits.

- a. **Temporary fix:** bypass the photocell and use a circuit breaker for manual operation.
- b. **Permanent fix:** Install photocell K4136M (Canrig Part # E19578) or equivalent alternative.
